### Inspection Report

#### Minerals Regulatory Program

**Mine Name:** Bonanza

**Operator Name:** American Gilsonite

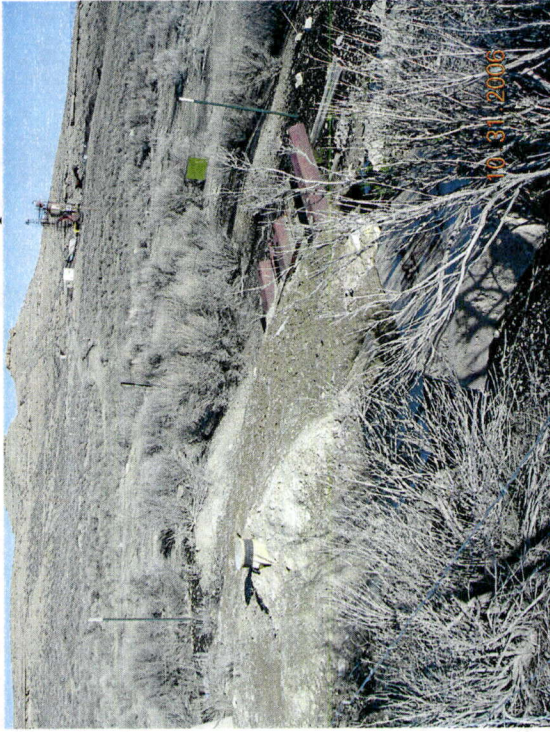
Photo 1. B-14.

Site B-14 was originally constructed prior to 1975, but the site has been used since that time to pump water from the mine. It is located near B-28 not far west of the town of Bonanza. There are some footings that need to be disposed of, and it will need a cap.

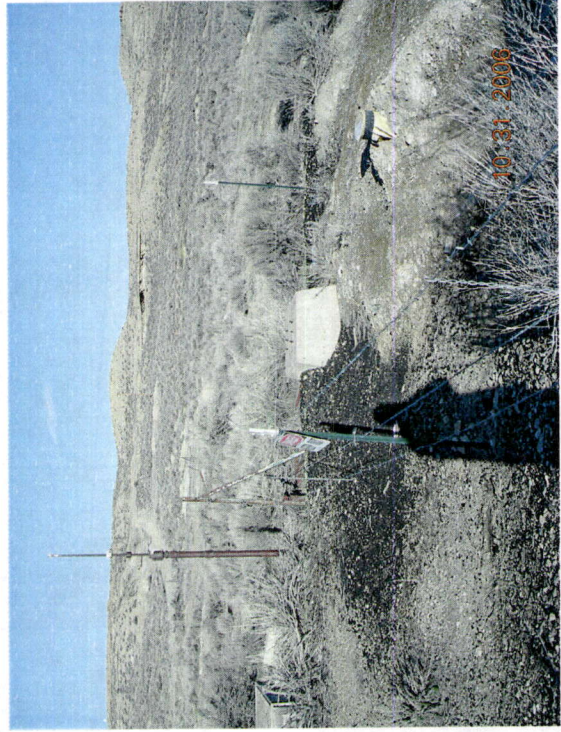
Photo 2. Another view of B-14.

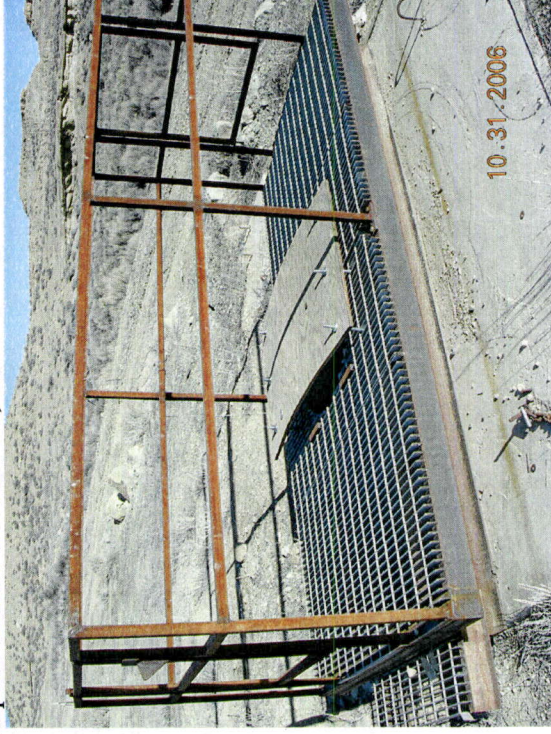
B-28 is a little to the west of B-14. It is shown in Photos 3 and 4. There are two openings that will need to be closed. One is about two feet in diameter, and the other is about five feet.

Photo 3. This is a portion of B-28. Under the grate is an opening about two feet in diameter.

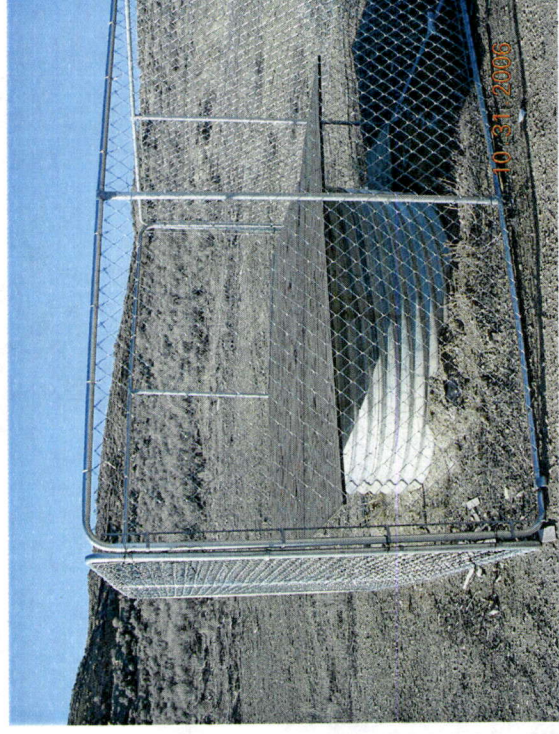
Photo 4. This is also part of B-28.

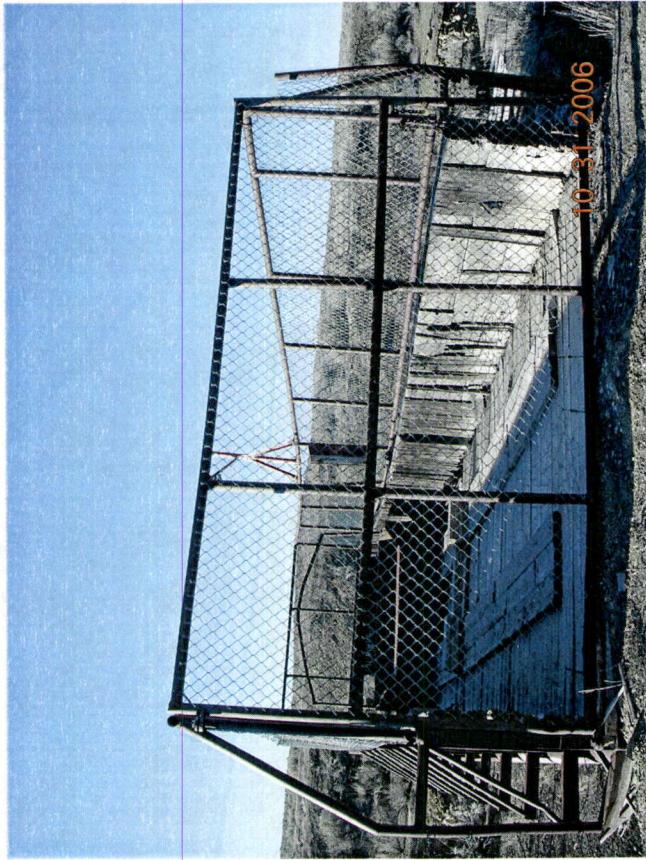
E-21 is an old trash disposal area that has apparently not been used in several years, but it is carried on the reclamation surety. It consists of a metal and plank structure across an open Gilsonite vein (Photos 5 and 6)

**Photo 5. The structure over the trench at E-21. Trucks carrying trash would back up onto this structure and dump the garbage.**

Mr. Jackson expressed concern about reclamation of E-21. Although the structure has been used for disposing of trash, the operator does not want to be responsible for reclamation of the entire open vein. I will recommend that reclamation include simply getting rid of the structure and ensuring the fence is secure.

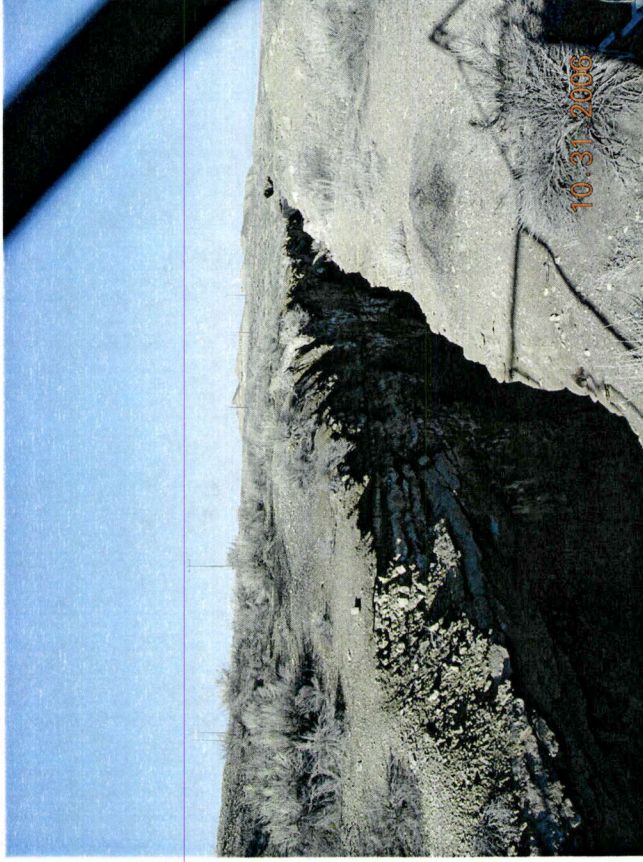
**Photo 6. The open trench at E-21.**
